INTERLAKEN DAM

NDI ID NO. PA-01037
DER ID NO. 35-087

PHASE I INSPECTION REPORT NATIONAL DAM INSPECTION PROGRAM

JUNE 1981

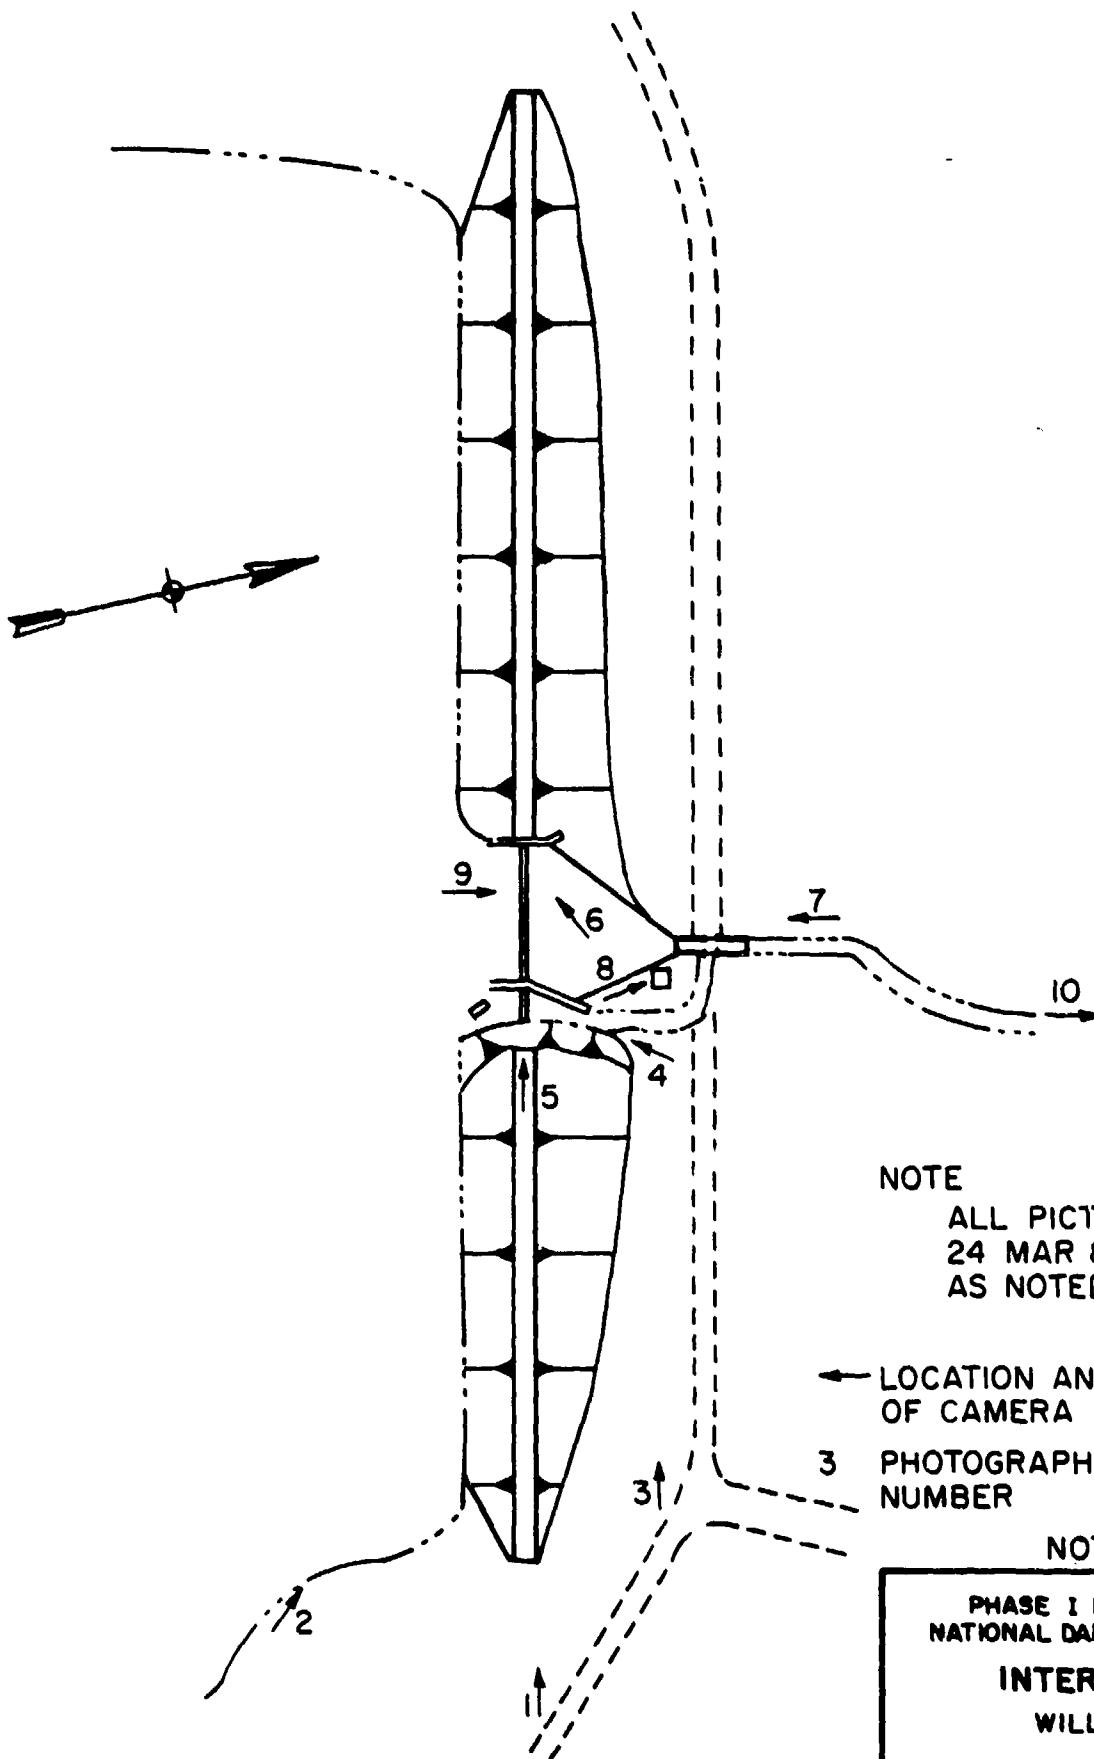
PHOTOGRAPHS

At the time of inspection, normal flow was passing through a breach located immediately adjacent to the right spillway wall. Flow also was passing under the spillway cap. The owner has been requested by PennDER to draw the reservoir down until such time as this condition can be corrected.

The spillway is located near the center of the dam. The crest consists of a 16 inch high by 18 inch wide concrete cap on the corewall. This cap is cracked and leaning downstream. Water is flowing under the cap near its right end at the rate of approximately 2 gallons per minute. The concrete spillway walls are severely deteriorated. The upstream wingwall on the right side has partially collapsed. The remaining portion of the wall adjacent to the crest is precariously balanced on a narrow piece of concrete. The adjacent breach through the embankment has removed any lateral support for the wall. It is apparent that the right wall was raised in the past since large slabs of concrete are cracking along regular horizontal lines which appear to be joints. The upstream wingwall on the left side has cracked at the crest and settled six inches. The discharge channel immediately downstream of the weir is a concrete slab which was placed over riprap. The concrete is cracked and is being undermined along the edges. This slab is initially the same width as the weir but narrows immediately and all flow is directed into a 3.5 foot high by 4 foot wide rock culvert. Flows in excess of the capacity of this culvert flow over the dirt road at the toe of the dam causing some erosion. This erosion would not be sufficient to threaten the safety of the dam.

4.5 Evaluation. The breached area and spillway are areas that should be repaired immediately. Routine maintenance of the facility should include removal of trees, brush, and high weeds. Formal manuals of maintenance and operation are recommended to ensure that all needed maintenance is identified and performed regularly. In addition, a formal warning system for the protection of downstream inhabitants should be developed. Included in the plan should be provisions for around-the-clock surveillance of the facility during periods of unusually heavy precipitation.
